REGIONAL GEOLOGY AND
METHODOLOGY OF GROUND-WATER ACCESS
LEE'S LANE LANDFILL
JEFFERSON COUNTY, KENTUCKY

NUS CORPORATION
SUPERFUND DIVISION

TDD NO. F4-8212-126
CONTRACT NO. 68-01-6699

APRIL 16, 1984

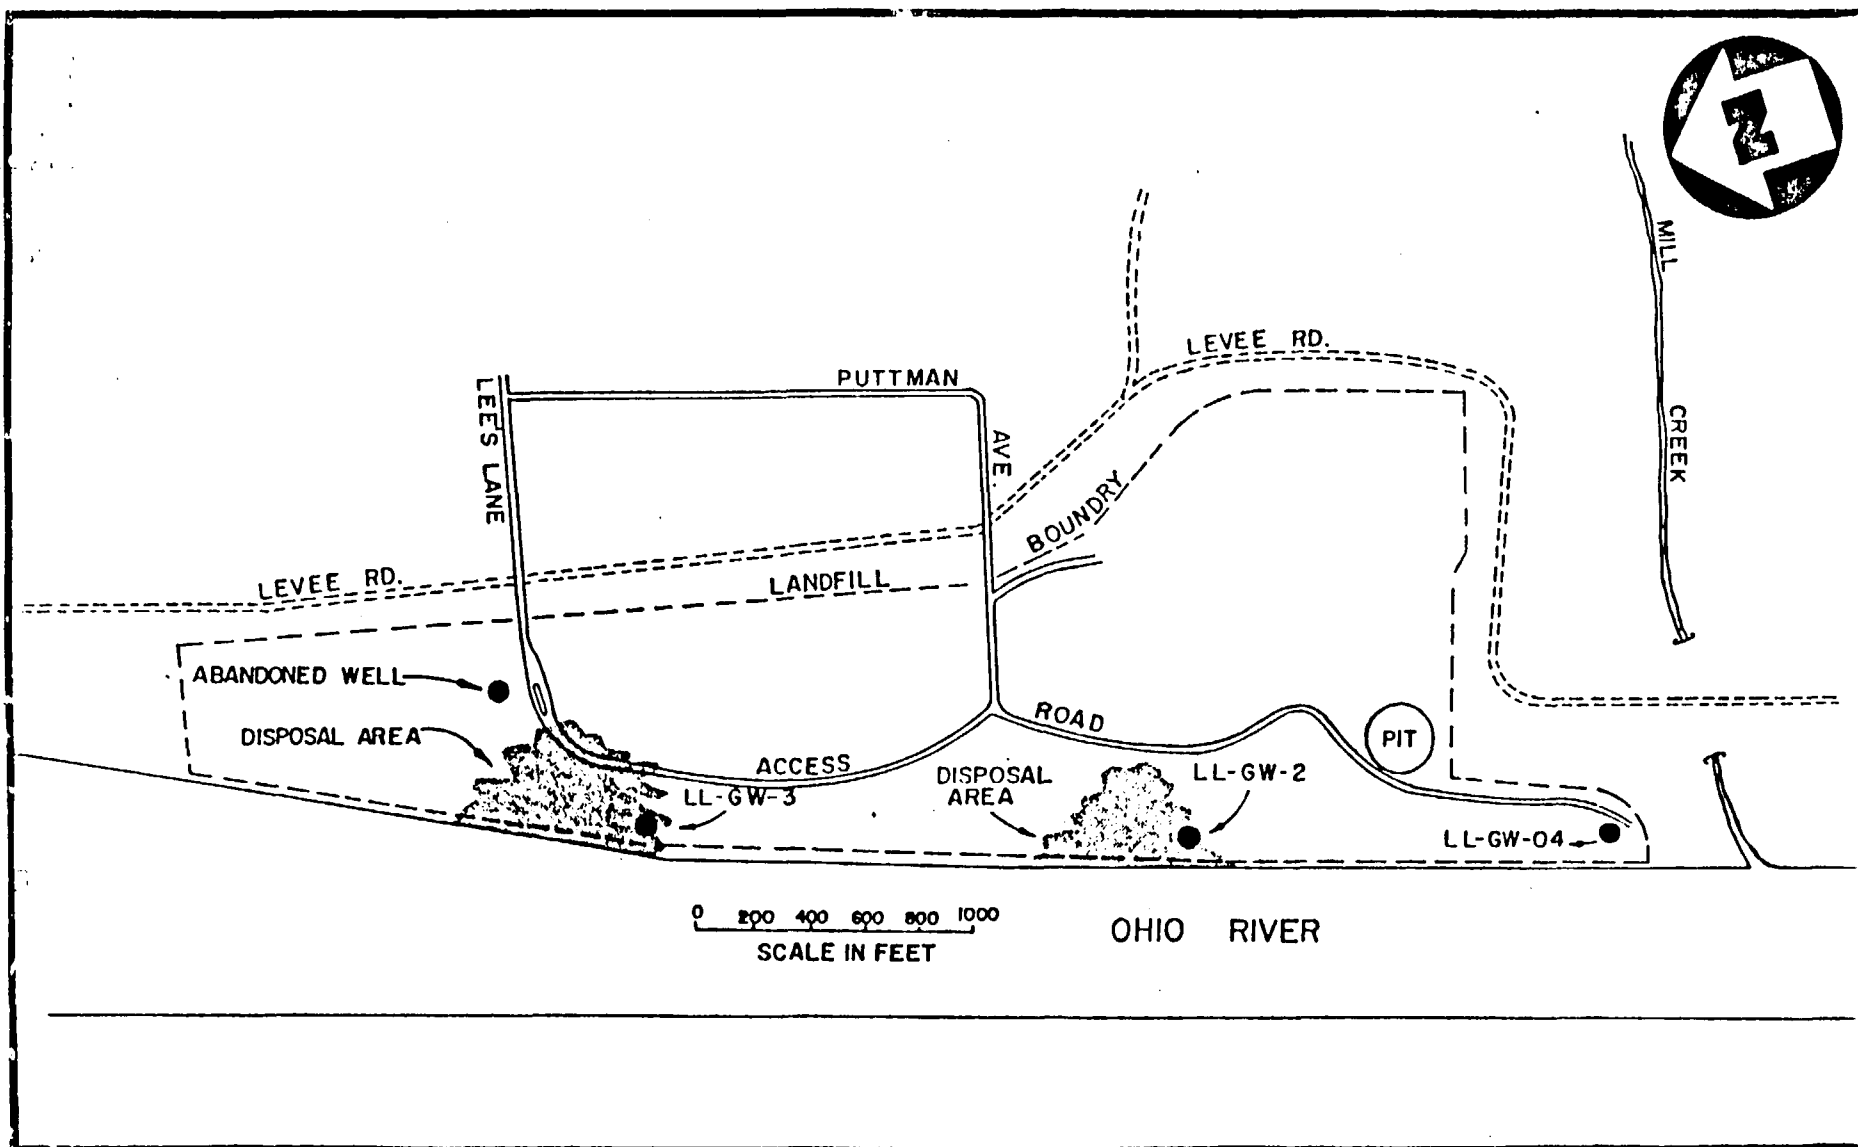
FIGURE 1.2

LL-GW-01 LOCATED IN RIVERSIDE GARDENS PARK

WELL LOCATION MAP
LEE'S LANE LANDFILL
JEFFERSON CO., KY.

From the date of abandonment to the date of remobilization, the well-installation methodology was amended. The drill crew and FIT were to be prepared to work under Level B respiratory protection when air-monitoring equipment indicated the concentration of organic vapors to be above that of the ambient air. A 12-inch diameter hole was to be augered to the water table in the landfill. A sample of this water was to be taken. The hole was then to be extended through the landfill and 10-inch diameter corrugated metal pipe was to be installed in the temporary hole. The metal pipe was to extend the entire thickness of the landfill in order to prevent the migration of landfill waters into the aquifer. By casing the landfill off, FIT anticipated that the wells could be completed in level D protection since the concentration of contaminants should be lower in the alluvium that underlies the landfill. The wells were to be completed as permanent ground-water wells with the corrugated pipe removed. Due to the presence of explosive gases, the EPA Deputy Project officer and the NUS Project Manager proposed the number of wells to be completed be reduced to four. This suggestion was based on the intentions to fulfill the original objectives of the project without exposing those involved to unnecessary risks due to the explosive gases. An upgradient well, LL-GW-1, was installed in Riverside Gardens Park (Fig. 1.1). LL-GW-2, LL-GW-3, and LL-GW-4 were installed on the landfill in locations considered to be down the hydraulic gradient of major waste-disposal areas as indicated by the 1982 geophysical survey (Fig. 1.2).
